Tecnológico
de Monterrey

- Antifungal properties of ZnO and TiO₂ NPs in cultural heritage

- CASE STUDY: SAN JUAN BAUTISTA

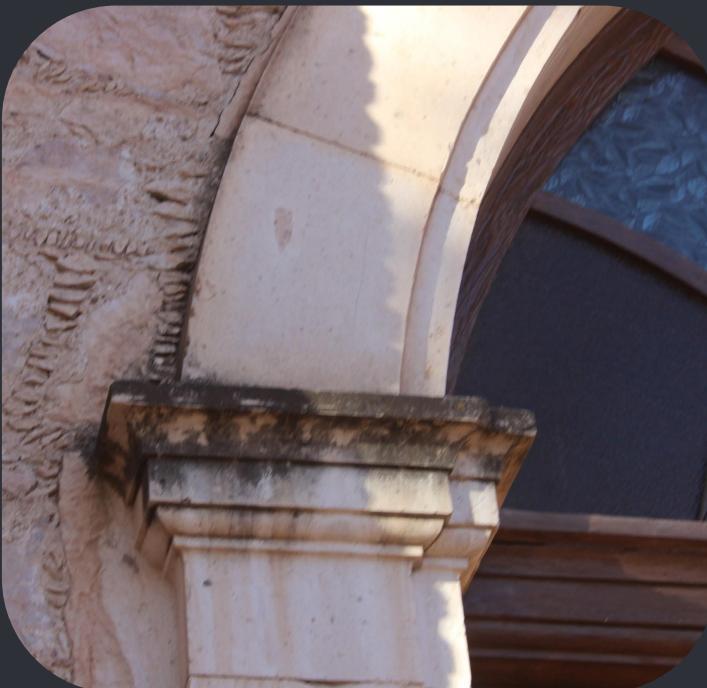
Figure 1. Damaged quarry stone

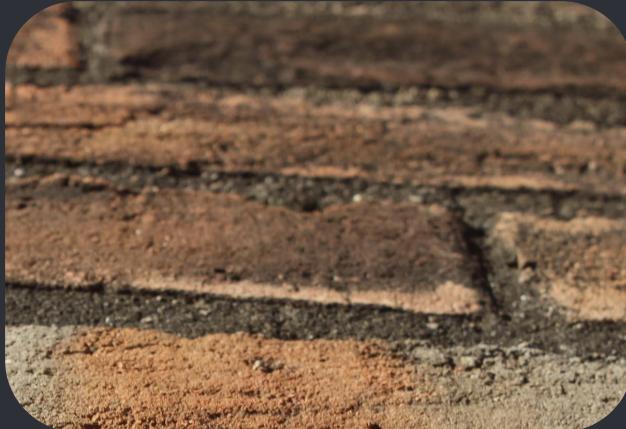
Figure 2. Damage over brick and mortar

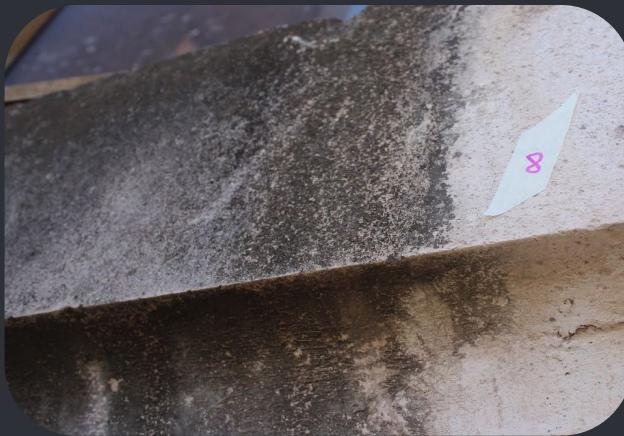
Figure 3. Damage over quarry stone

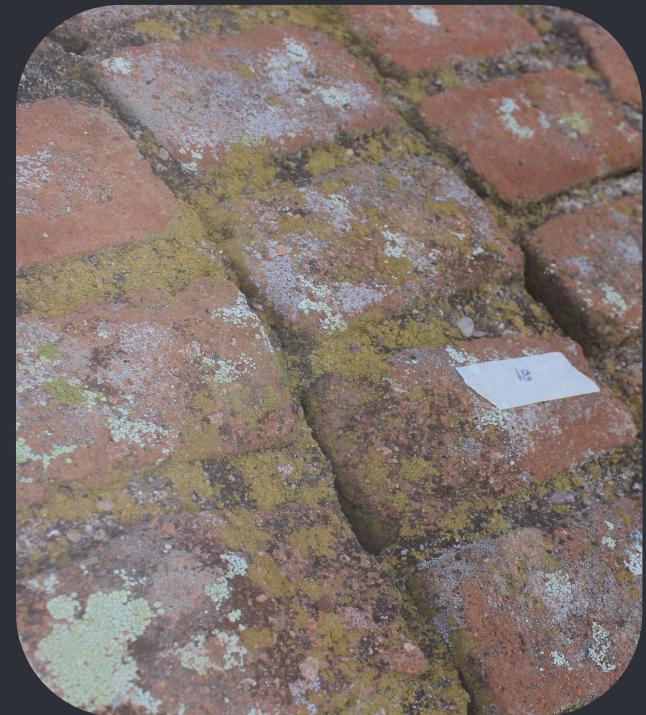
Figure 4. Damage over brick (mustard lichen)

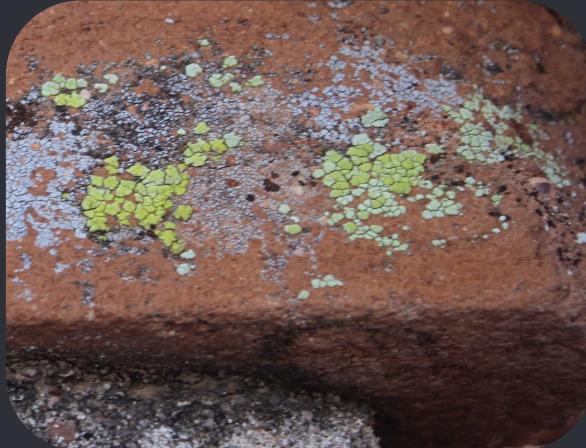
Figure 5. Damage over brick (green lichen)

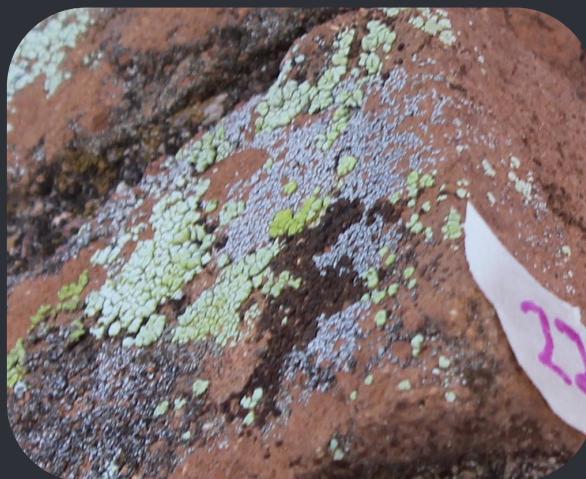
Figure 6. Damage over brick (gray lichen)
